SITE SPECIFIC FLOOD RISK ASSESSMENT

Land off Howlett Way, Trimley St Martin

Client(s): Trinity College, Cambridge

Project no: 48055

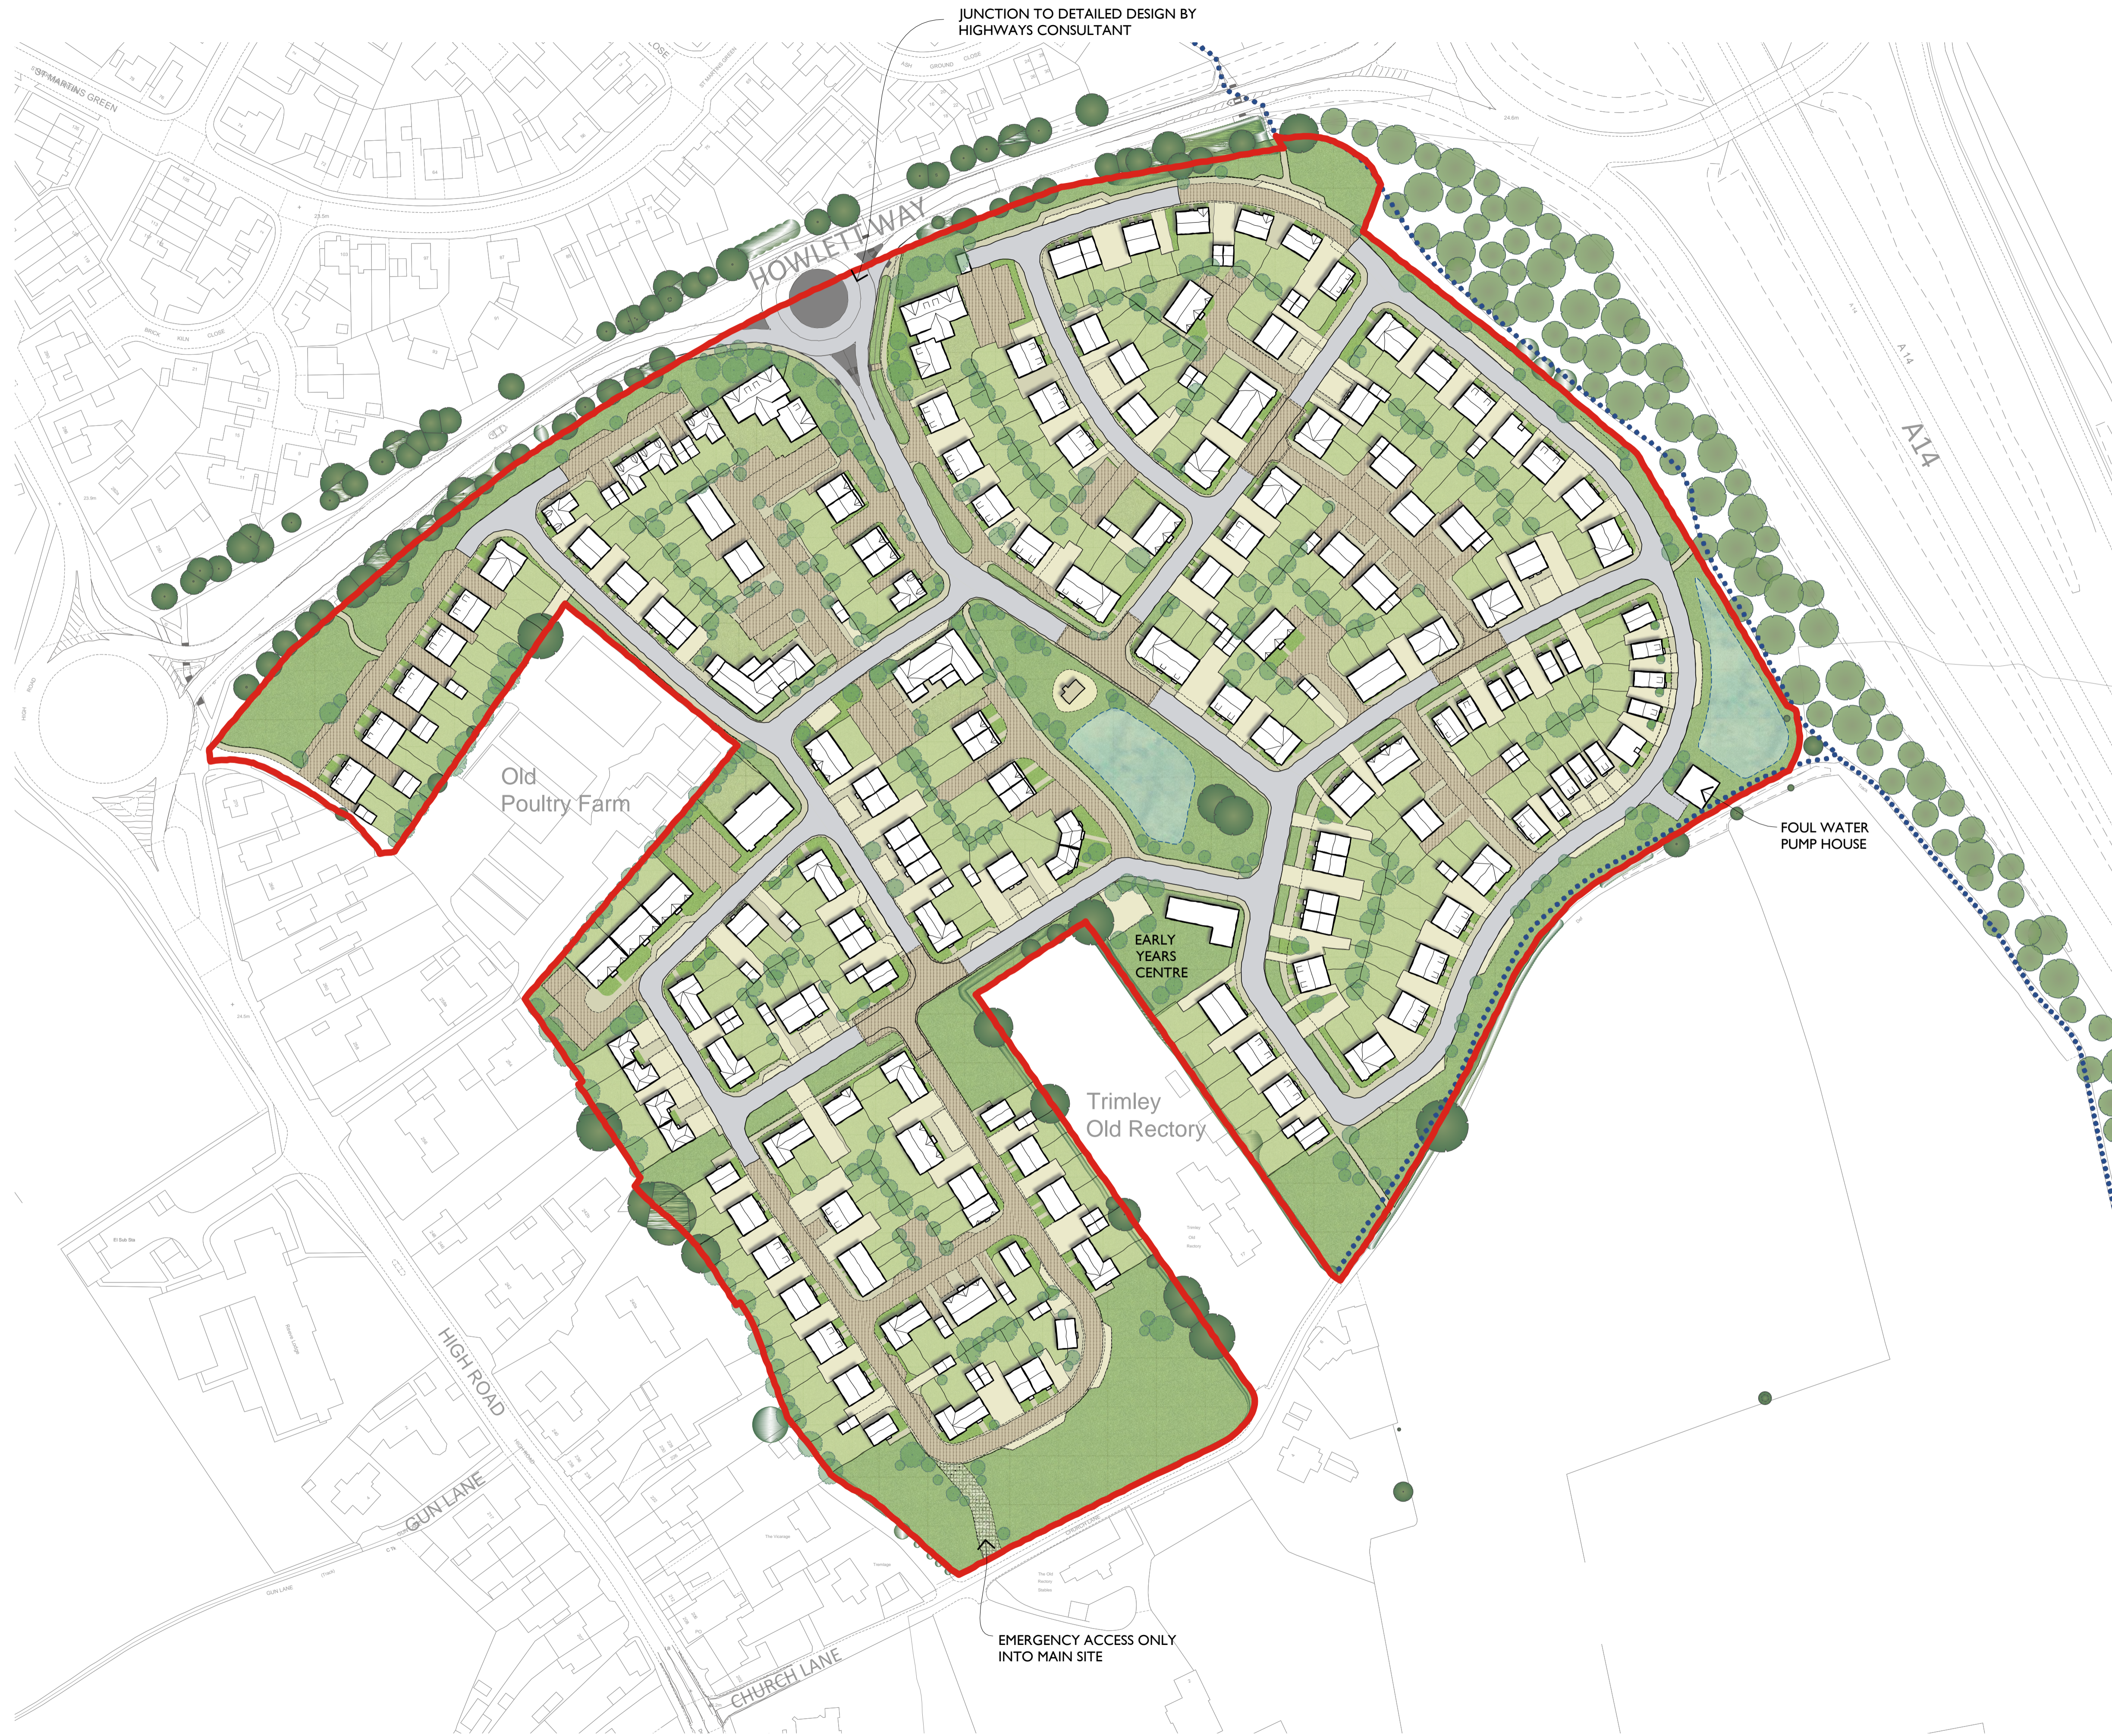
Scale 1:1000 @A1	Date Dec 2019
Drawn SD	Checked AL
Drawing Number 7845/P101	Revision A

-   FLATS
-   HOUSES
-   PROPOSED DRAINAGE BASINS
-   PROPOSED ZEBRA CROSSING
-   EXISTING MATURE TREES (UN-SURVEYED)
-   EXISTING PUBLIC RIGHT OF WAY (SHOWN BLUE DOTTED)

Title
ILLUSTRATIVE SITE LAYOUT

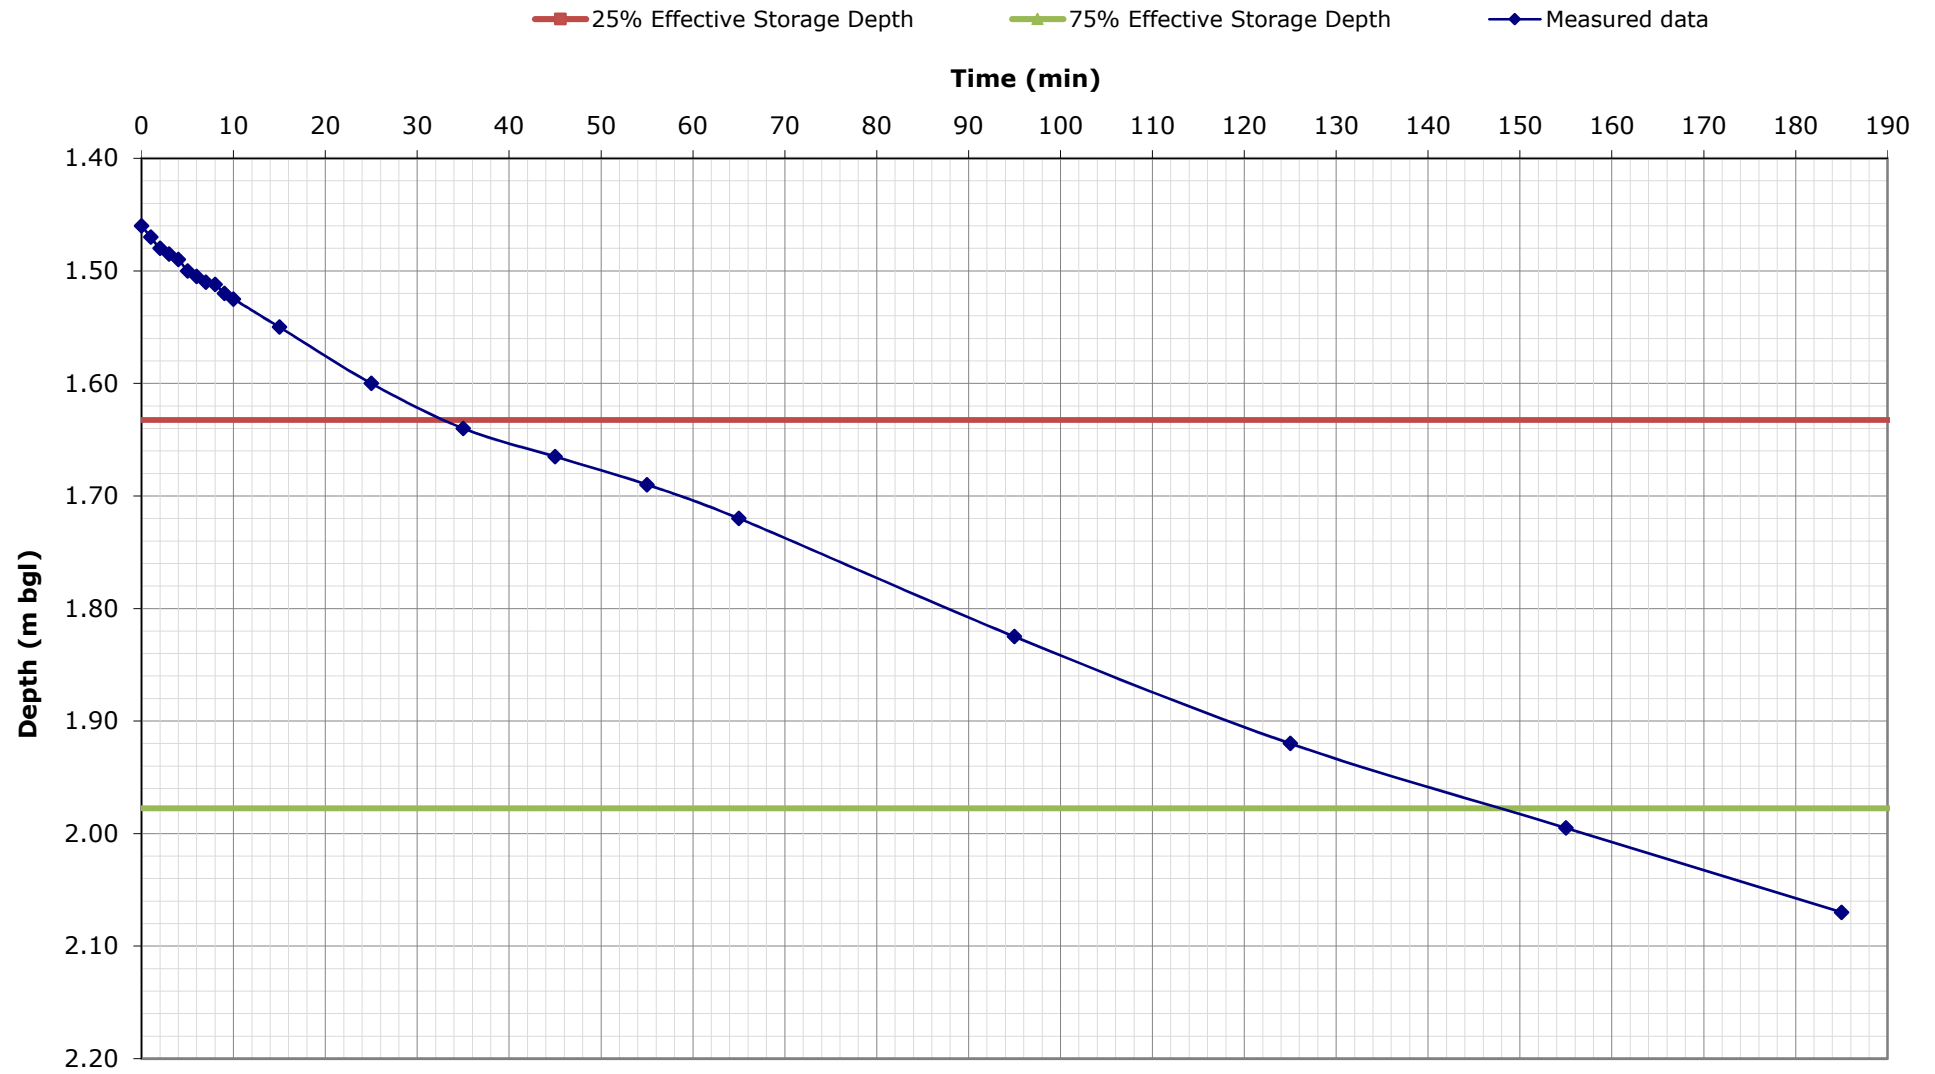
48055 - Land off Howlett Way, Trimley St. Martin, Suffolk - TP1 - Test 2 of 2

<u>Infiltration TP1 - Test 2 of 2</u>	
Date: 30/04/2018	
<u>Trial Pit Dimensions</u>	
Length (m)	1.30
Width (m)	0.45
Depth (m)	2.15
Effective Depth (m)	0.69
tp ₇₅ (mins)	148
tp ₂₅ (mins)	33
<u>Calculations</u>	
V _{p75-25}	0.20
a _{p50}	1.79
tp ₇₅₋₂₅	115
f = 1.6318E-05 m/s

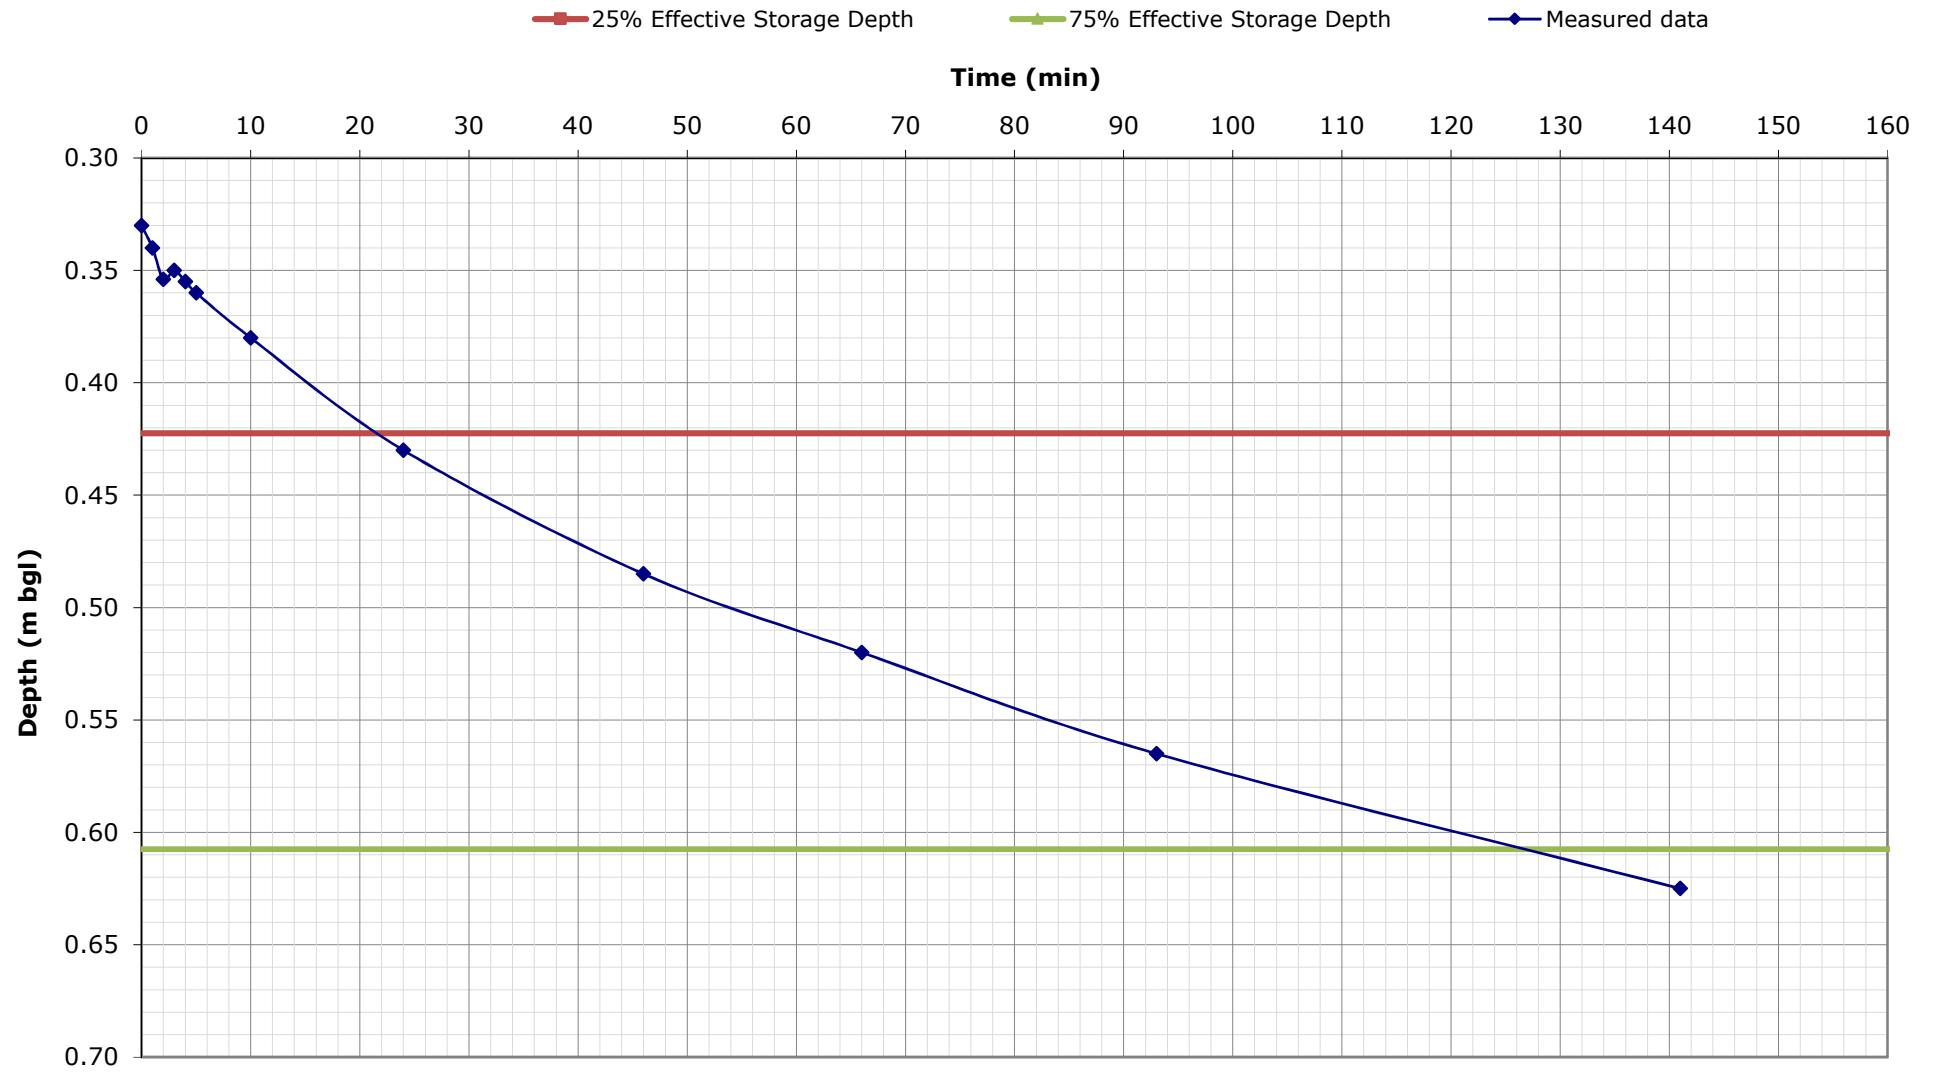
48055 - Land off Howlett Way, Trimley St. Martin, Suffolk - TP4 - Test 1 of 2

<u>Infiltration TP4 - Test 1 of 2</u>	
Date: 30/04/2018	
<u>Trial Pit Dimensions</u>	
Length (m)	1.60
Width (m)	0.55
Depth (m)	0.70
Effective Depth (m)	0.37
tp ₇₅ (mins)	127
tp ₂₅ (mins)	21
<u>Calculations</u>	
V _{p₇₅₋₂₅}	0.16
a _{p₅₀}	1.68
t _{p₇₅₋₂₅}	106
f = 1.52775E-05 m/s
